Post August 2017 flood image of part of Bardya district, Nepal

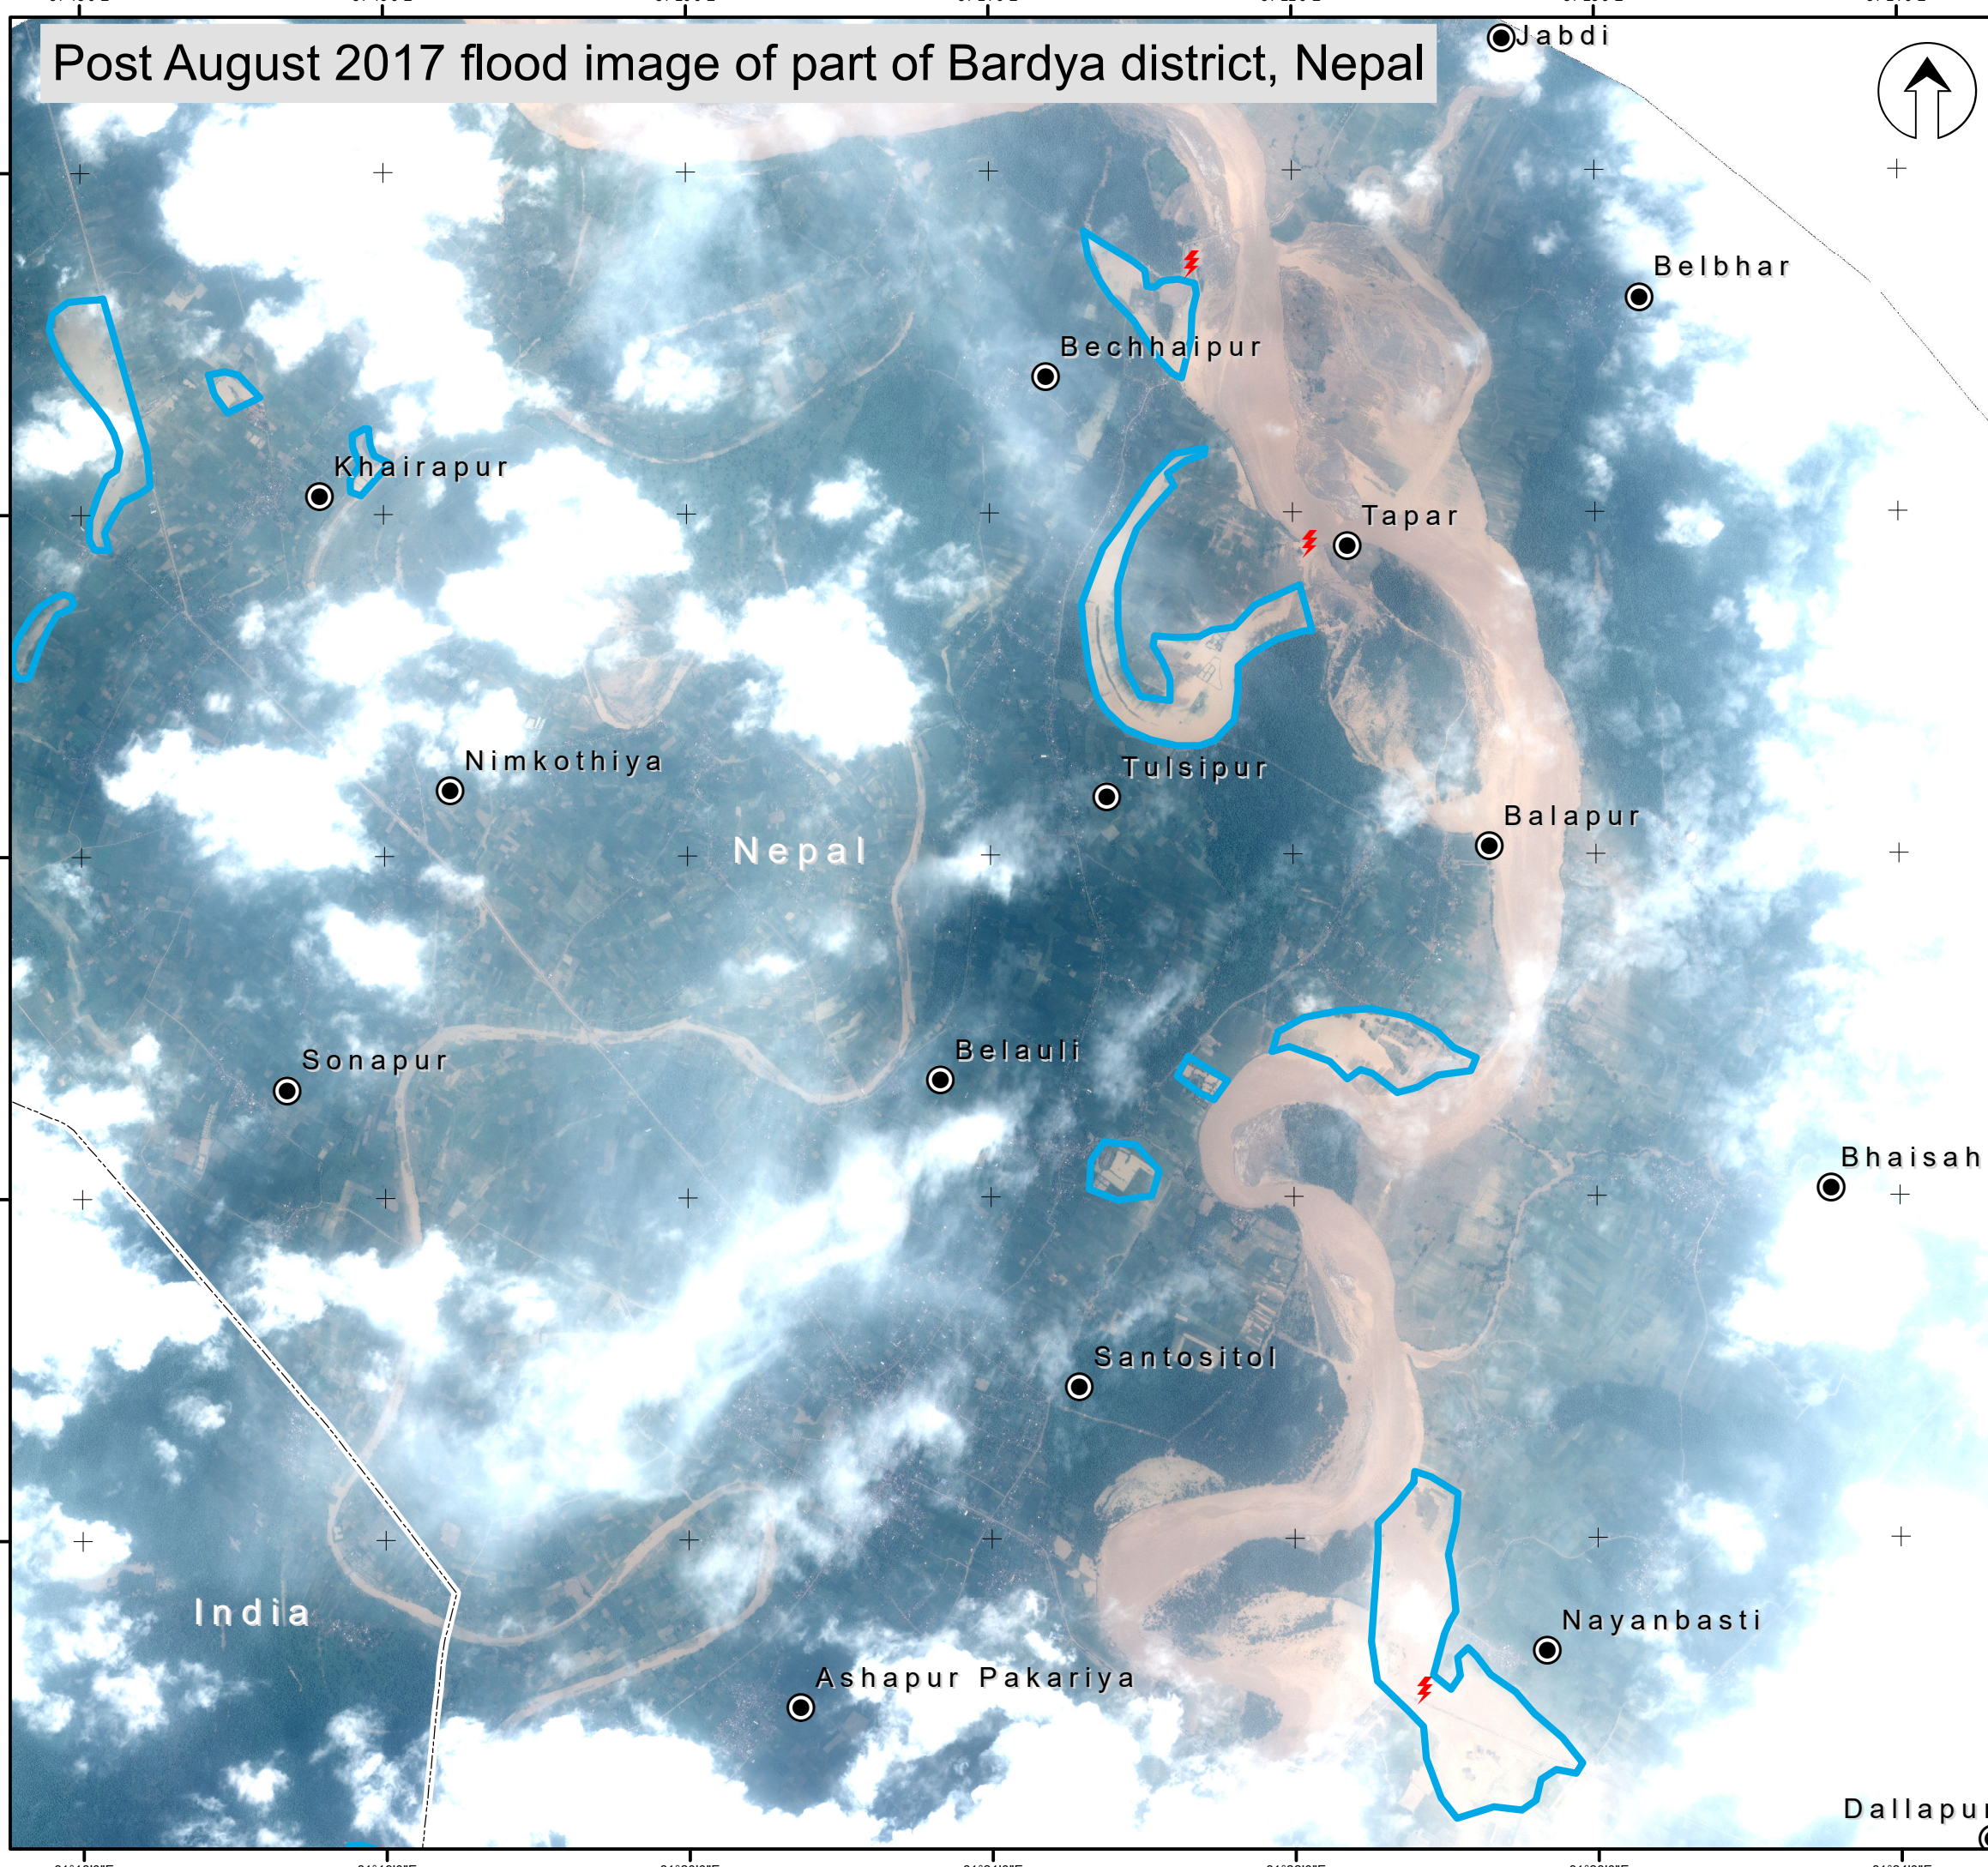
The image shows wide spread flooding not only along the river corridor but also other low lying areas. The flood has receded since the peak event, leaving scar from erosion and deposition prominently visible. There are some water logged areas still visible and some are close to settlement area (indicated by blue polygon). The flood had inundated road infrastructure in many stretches and highly likely that it was damaged at 3 place.
