NEPAL

MELAMCHI MUNICIPALITY, BAGMATI PROVINCE

IMAGERY ANALYSIS: 24 JUN 2021 PUBLISHED 5 JUL 2021 V1

Landslides impact analysis in Melamchi municipality, Bagmati province, Nepal as of 24 June 2021

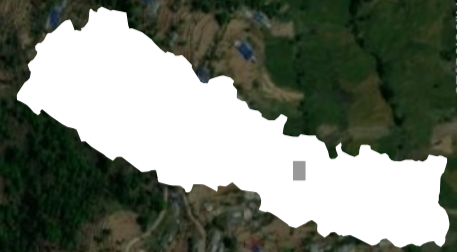
This map illustrates satellite-detected flash floods and landslides in Melamchi village, Melamchi municipality, Bagmati province, Nepal as observed using a Sentinel-2 satellite imagery acquired on 24 June 2021. Within the analyzed area, approximately 150 structures appear to be potentially affected by the landslides.
